Original Article

Assessment of a highly-filled flowable composite for the repair of indirect compositesÖzlem Kanar¹⁾, Simge Meşeli¹⁾, Bora Korkut¹⁾, Serhat Köken²⁾, Dilek Tağtekin¹⁾, and Funda Yanıkoğlu³⁾¹⁾Department of Restorative Dentistry, Faculty of Dentistry, Marmara University, Istanbul, Turkey²⁾Department of Prosthodontics and Dental Materials, School of Dental Medicine, University of Siena, Siena, Italy³⁾Department of Restorative Dentistry, Faculty of Dentistry, Istanbul Kent University, Istanbul, Turkey

Abstract

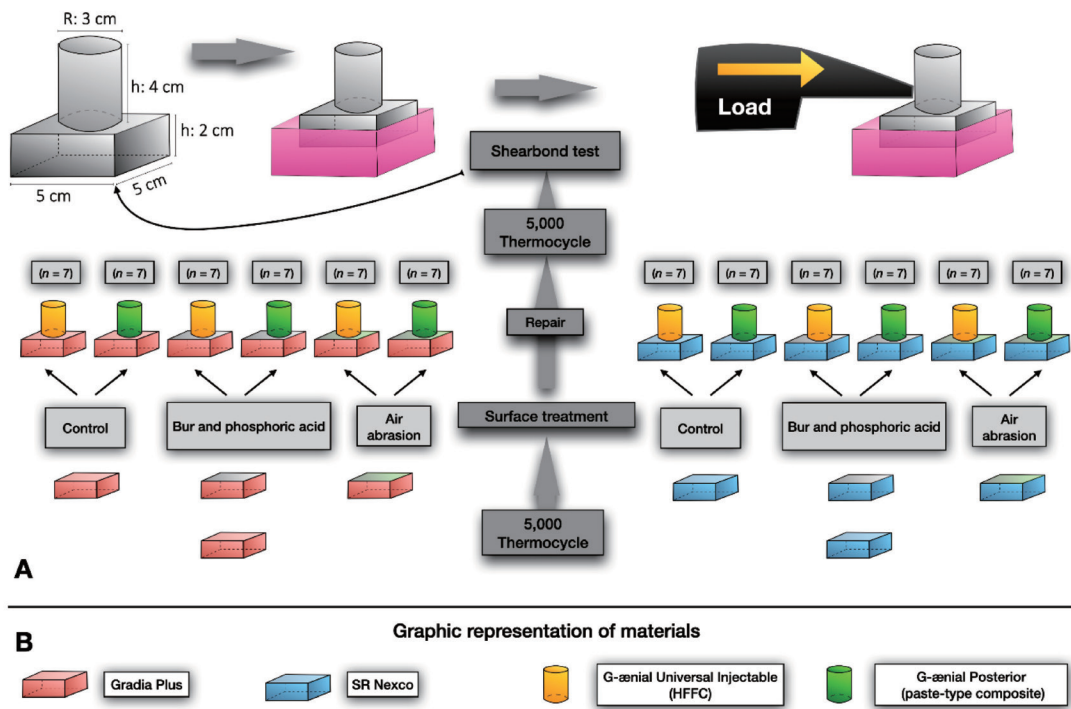
Fig. 1 Flowchart of the study

All samples were embedded in cold acrylic with 2 mm of it remaining on the surface (Fig. 1). Each base material (BM) was divided into three groups according to the ST and then divided into two sub-groups for RM ($n = 7$).

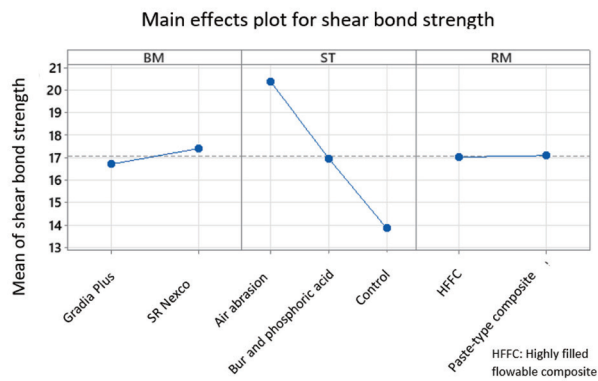
**Fig. 2** Mean plot of main effects: surface treatments, base materials, and repair materials

ST and ST- RM interactions were compared with a three-way ANOVA test. The test results revealed that the ST ($F = 10.301$, $P < 0.001$) and ST-RM interaction ($F = 3.266$, $P = 0.044$) exhibited a significant influence on repair SBS values (Table 4). The base material (BM) was not considered an effective factor for SBS ($P = 0.557$). Regardless of the RM and ST, SBS values for SR Nexco and Gradia Plus BMs were 17.4 ± 7.1 and 16.7 ± 5.3 , respectively. The mean plot of the main effects of BM, RM and ST are given in Fig. 2.

Although HFFC shows comparable results to paste-type composites in terms of adhesion (Fig. 2), the second hypothesis may be partially rejected due to the higher SBS obtained from the air-abrasion and HFFC group (Table 4). Still, the HFFC in the bur and phosphoric acid ST group exhibited comparable SBS to the paste-type composite (Fig. 2). Similarly, another study included HFFC, and paste-type composites reported the same clinical performance on NCCL after two years of follow-up [39]. Other clinical research assessed the success of Class II restorations restored with HFFC and paste-type composite regarding the FDI criteria. At the end of 36 months of clinical follow-up, it was reported that HFFC and paste-type composites exhibited similar performance [27]. Zhang et al. compared the clinical performance of HFFC and paste-type composites on non-carious cervical lesions (NCCL). According to FDI criteria, both materials presented comparable results after three years of clinical evaluation, but HFFC showed better marginal adaptation on NCCL [40]. Based on these clinical studies and the present findings consistent with these results, it might be assumed that there is no limitation for using HFFCs as a finishing material in the composite repair protocol, without requiring a top material, according to the manufacturer’s instructions.

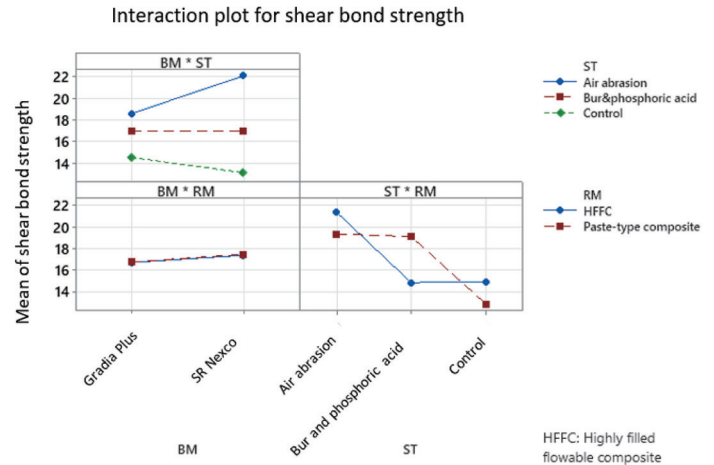
**Fig. 3** Mean graph of interactions: shear bond strength, surface treatments, and base material

In addition, the interaction among the three factors was significant (Table 4, $P = 0.013$). The mean graph of interactions is given in Fig. 3.

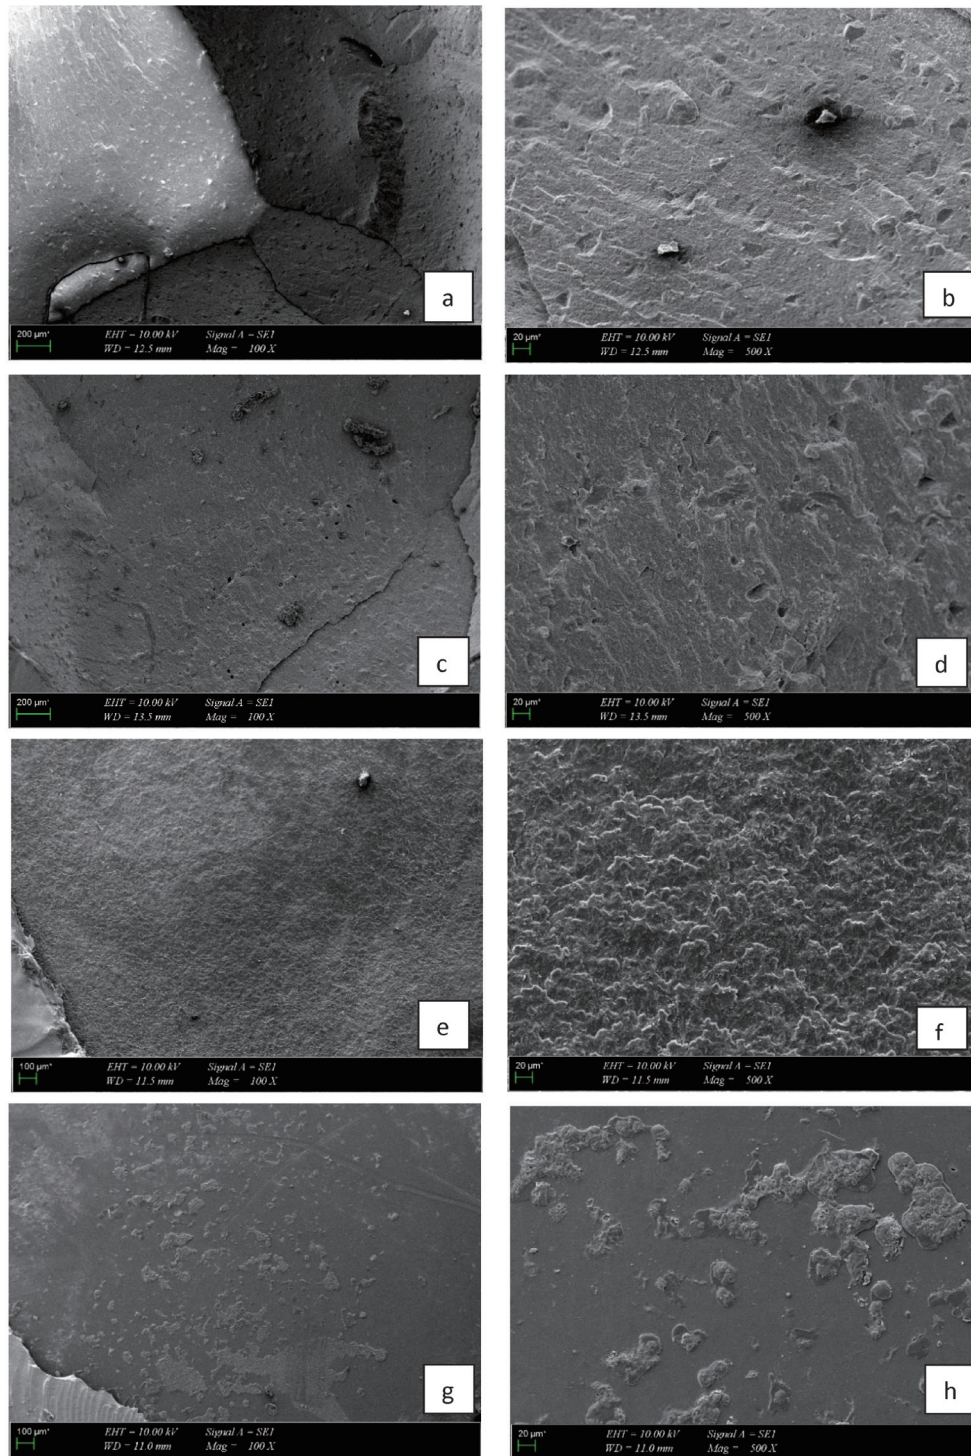
Fig. 4 SEM (scanning electron microscopy) examination of failure types (a, b) cohesive failure in the base material. (c, d) cohesive failure in the repair material. (e, f) adhesive failure. (g, h) mixed failure

SEM images of the failure types are given in Fig. 4, which are cohesive failure in BM (Fig. 4a, b), cohesive failure in RM (Fig. 4c, d), adhesive failure (Fig. 4e, f), and mixed failure (Fig. 4g, h), respectively.

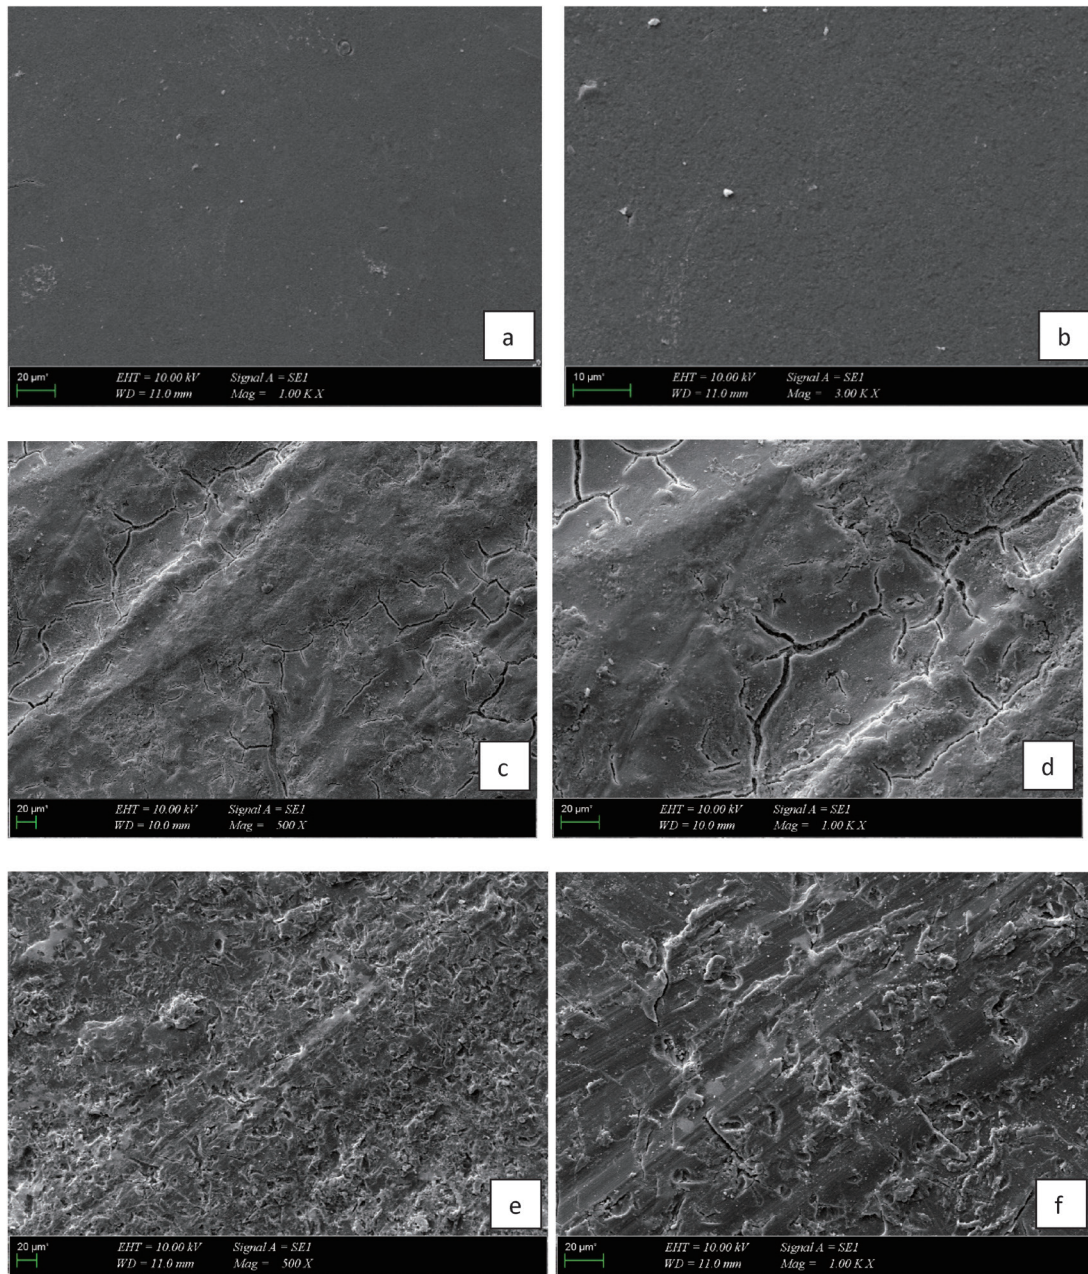
Fig. 5 Surface roughness of base materials after surface treatments (a, b) control. (c, d) bur and phosphoric acid. (e, f) air abrasion

The control group (no treatment) presented a smoother surface than bur and air-abraded surfaces (Fig. 5a, b). Bur ST revealed widespread cracks along the surface with shallower roughness (Fig. 5c, d). Air abrasion with $29 \mu\text{m Al}_2\text{O}_3$ particles (Fig. 5e, f) produced substantial surface irregularities, which could be supported by the highest shear bond strength.

Micromechanical retention on aged surfaces has been reported as one of the key mechanisms to achieving reliable repair bond strength [32]. In the present study, bur and air abrasion STs were examined in SEM (Fig. 5). It was observed that there were finer and irregular indentations on the air-abraded surface compared to bur ST, which may have contributed to the higher SBS (Fig. 5). Similarly, Palasuk et al. reported that in ST procedures of composite repair, bur ST showed lower bond strength than Al₂O₃ ST [33]. Şişmanoğlu et al. investigated the repair bond strength of various surface treatments with self-adhering flowable composite. Conversely, in that study, no significant difference was found between air abrasion with Al₂O₃ particles, air abrasion with silica-coated Al₂O₃ particles, and acid etching groups with universal adhesive application [34]. This difference may be because in the aforementioned study the negative control group without adhesive constituted half of the tested specimens, resulting in low bond strength data and affecting the statistical analyses.

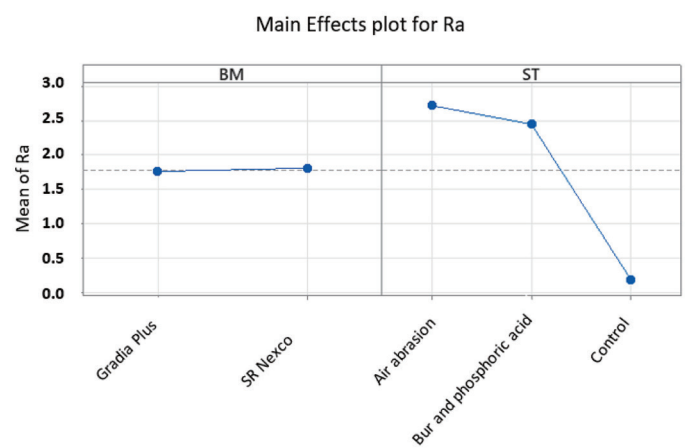
Fig. 6 Mean graph of interactions for Ra: base materials and surface treatments

Ra mean values did not differ according to the BM, regardless of ST ($P = 0.255$). The mean Ra is considered significant according to the ST regardless of the BM ($P < 0.001$) (Table 6). Each surface treatment differed from the other, and the mean Ra values were 0.19, 2.45, and 2.72 for control, bur and phosphoric acid, and air abrasion ST groups, respectively (Table 7). Ra mean values did not differ according to BM and ST interaction ($P = 0.847$). The mean Ra plot for the main effects is given in Fig. 6.
